# Non-Drip Brush Technology for OML Corrosion Remediation and Large area Anodizing

*Siva Palani, Alan Rose, Keith Legg, Corrdesa LLC*

AFCPCO Corrosion & Non-Chrome  
TIM

Feb 2025, San Antonio, TX

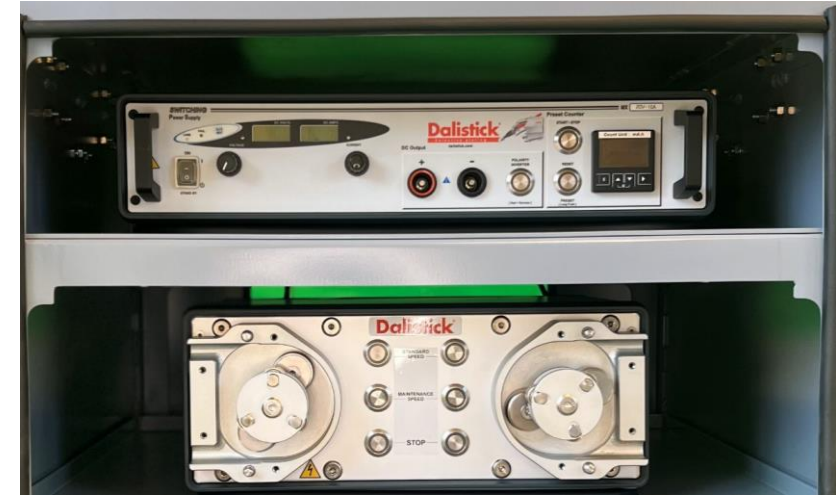
- Closed-loop electrolyte system
- Electrolyte in temperature-controlled bath
- Electrolyte is pumped into plating tool and air + electrolyte sucked back to tank

Non-drip Dalistick tool, platinized Ti anode

**Electrolyte and air flows balance so pad is wet but does not drip in any orientation**

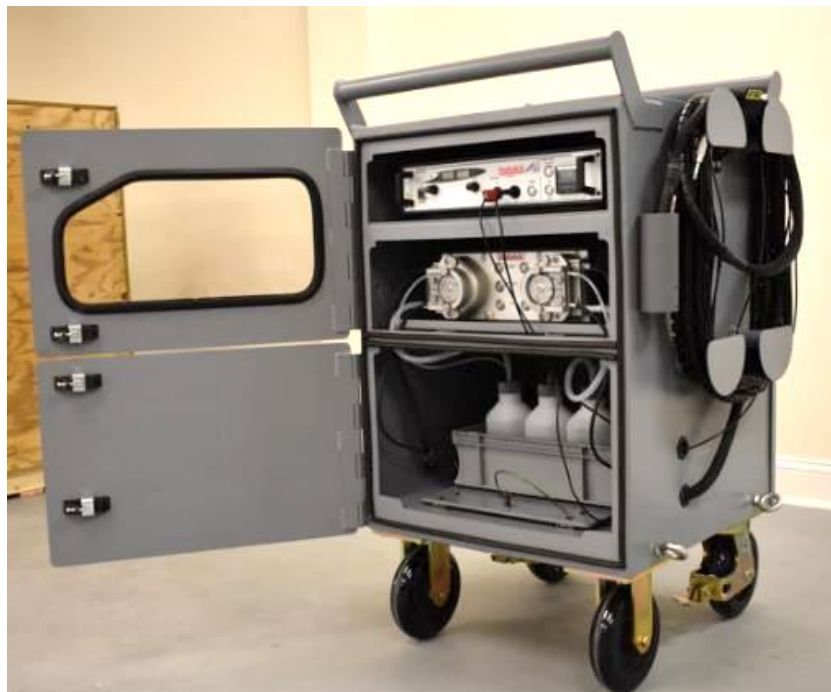
- GSE for repair of Cd and ZnNi electroplating on F-35 squadrons around the world
- Including use topside on aircraft and helicopter carriers
- 52 units delivered to date

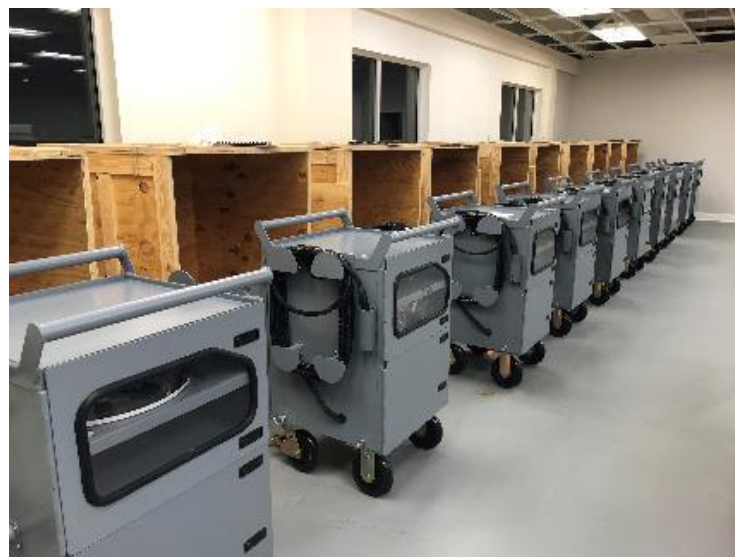
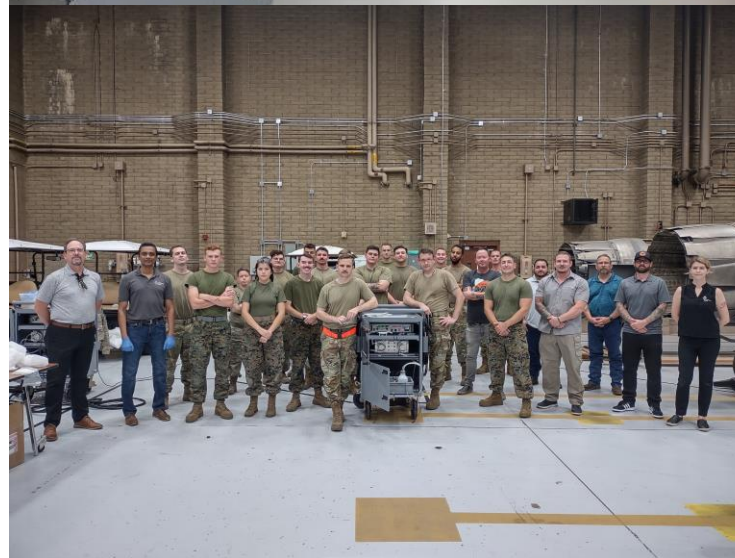
- ✓ Designed to be used on flight line or shipboard
- ✓ Tie Downs
- ✓ Brake hold on 15° slope
- ✓ No tipping at 15° with side force
- ✓ Aerospace finish for corrosion control
  - No chromates
- ✓ 20 ft tool cable for ATEX compliance
- ✓ 50 ft ground return from a/c
- ✓ Absolutely no FOD
  - All fasteners, etc. captured or Loctite

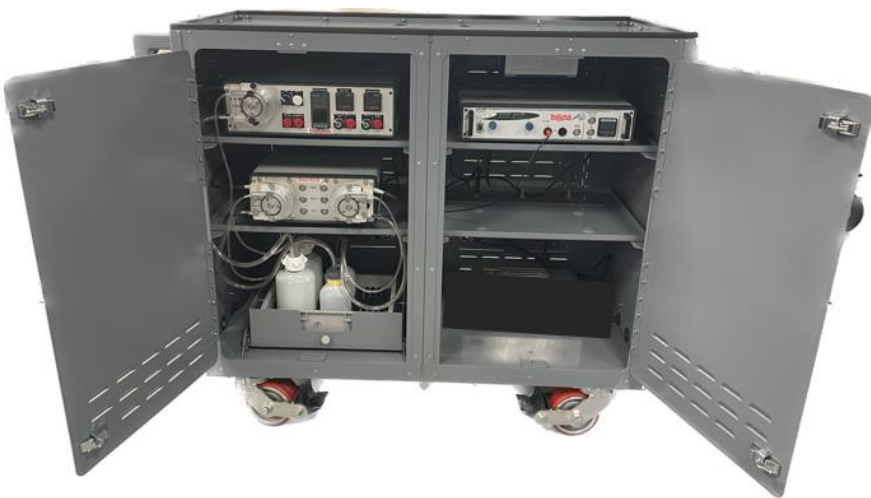
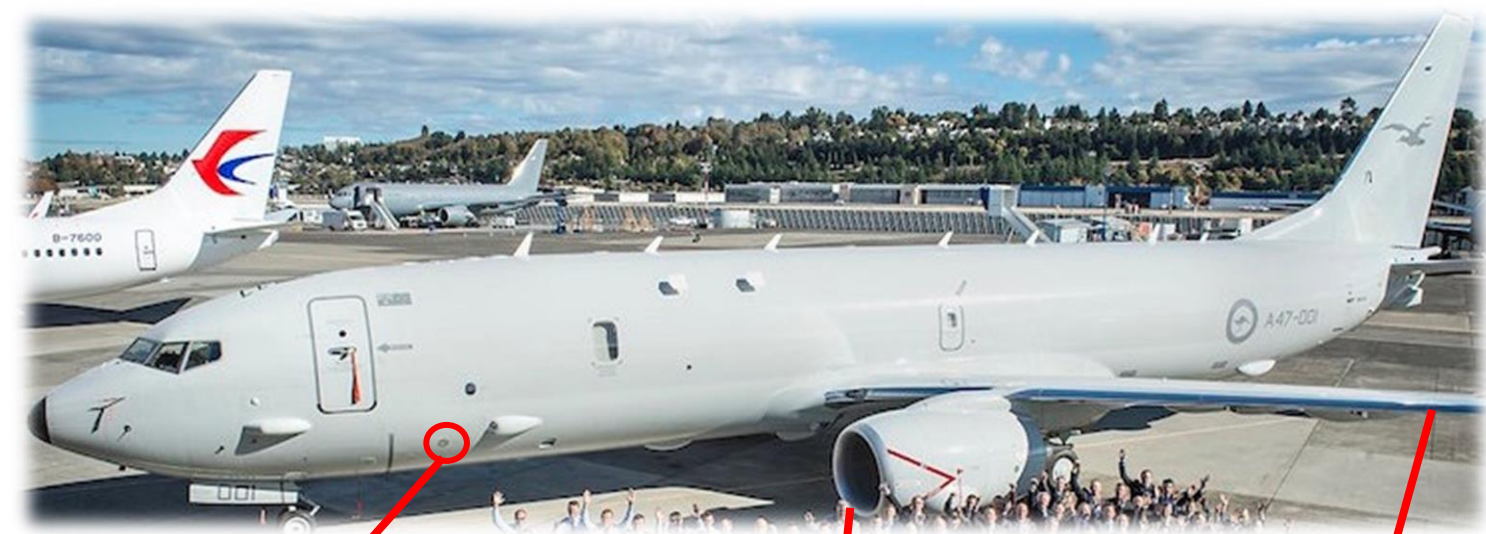
Static port – demo repair

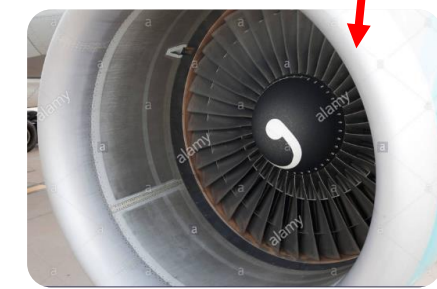
Engine Inlet: Extensive pitting  
ZnNi for smooth coating

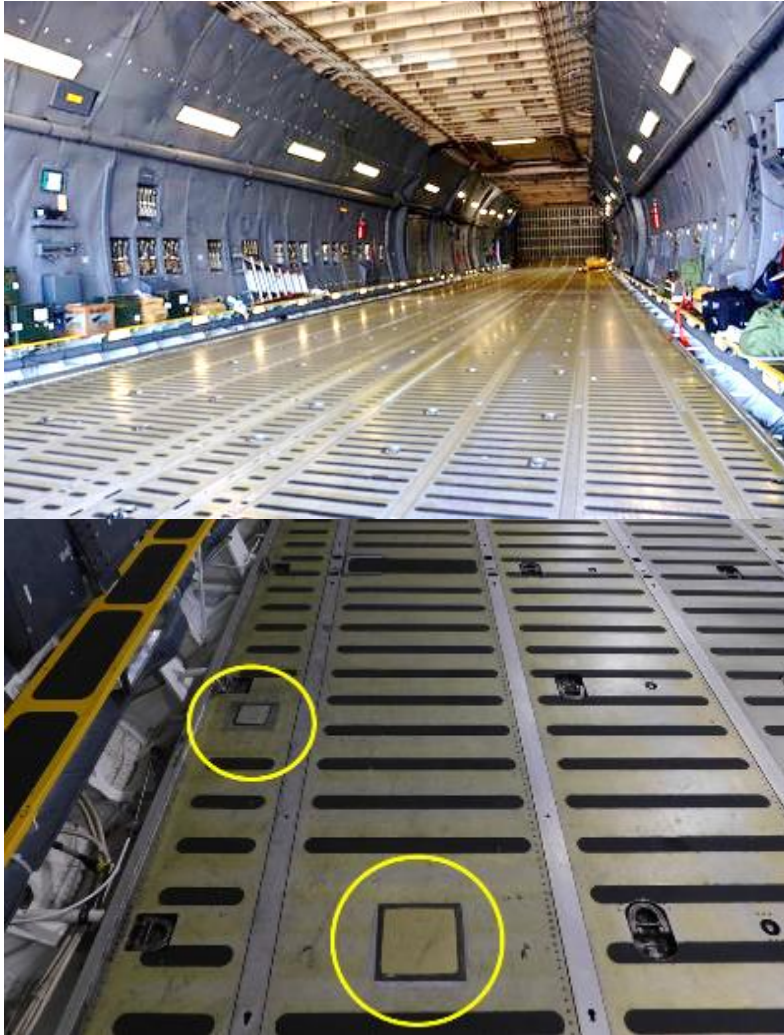
- Preparation for patch repair damages surrounding anodize

- Non-drip anodize surrounding aluminum after patch repair
- Rinse & seal anodize

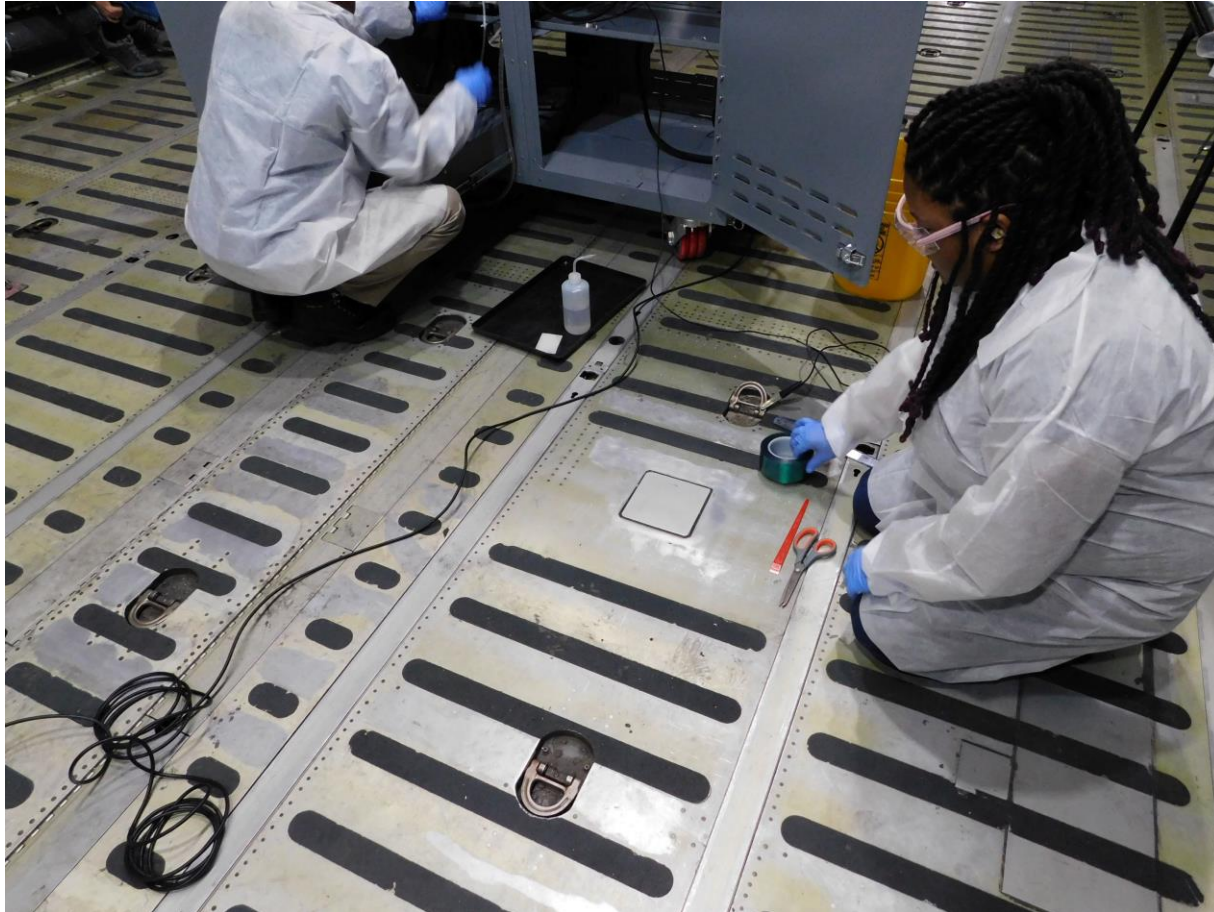
Surface preparation

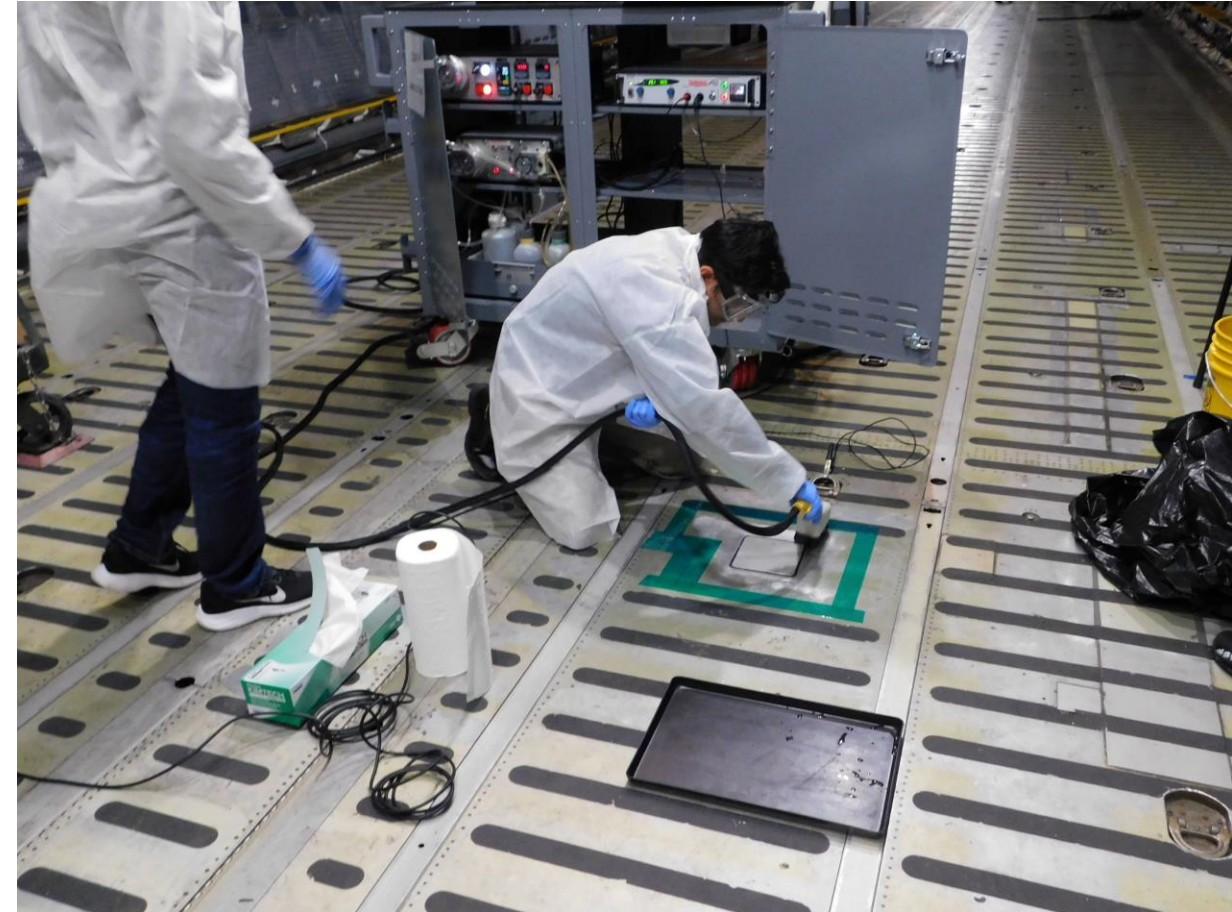
Anodize

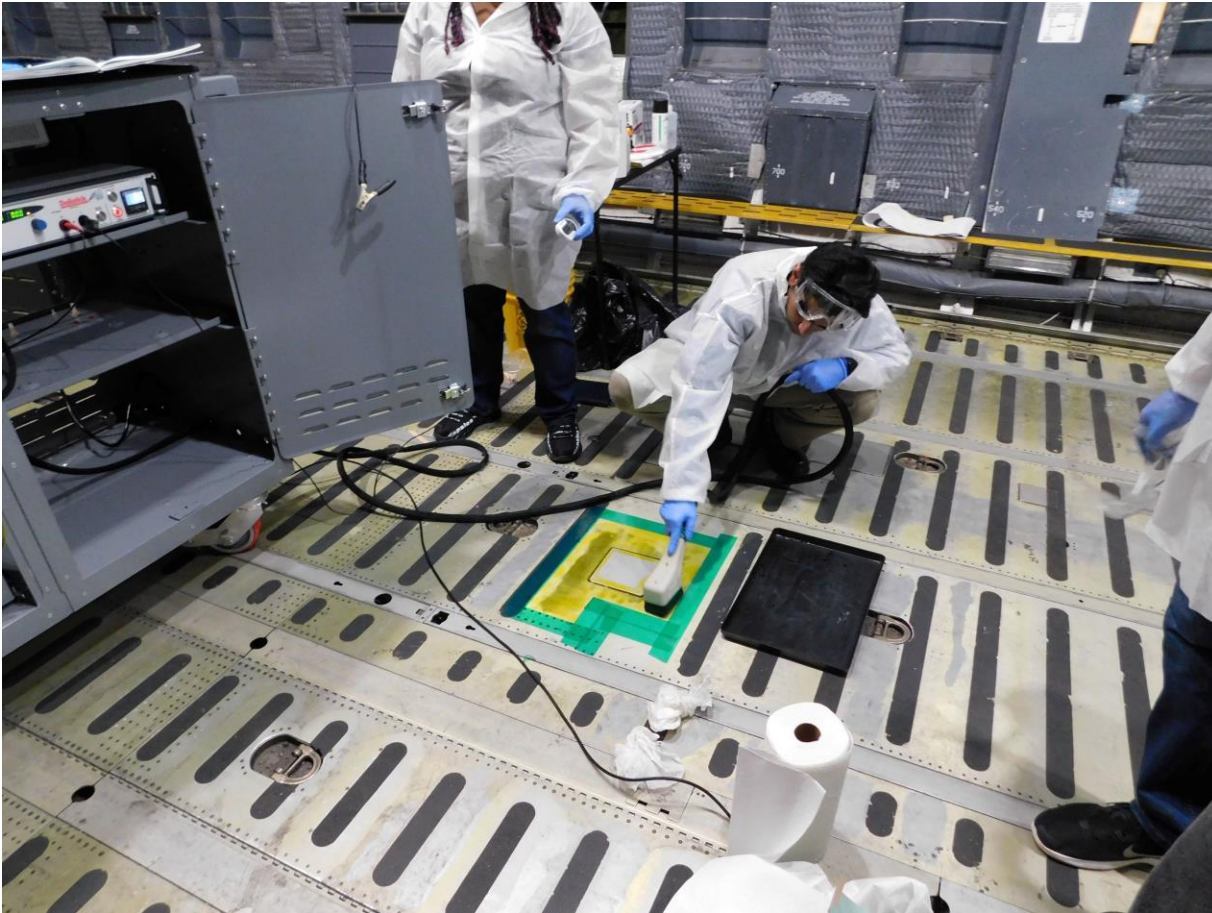
Seal
