Electroplates and anodize coatings protect aircraft, vehicles, and other equipment from corrosion and wear damage. But when the coating is damaged your only options are to let it corrode or send it out for a few months for repair. Corrdesa has developed a better alternative – a plating and anodizing shop on wheels. Our patented family of robust, mobile electrochemical treatment systems are used worldwide as Ground Support Equipment (GSE) to perform on-aircraft repairs with minimum set up time and no drips and spills to clean up. They are so convenient they are also used in production, where damaged parts can be touched up in place immediately to avoid interrupting production. Even coating damage from grinding and welding can be quickly remediated. Treatments use less hazardous, qualified materials, replacing Cd/Cr⁶⁺ with ZnNi/Cr³⁺, and CAA with SAA. There is even an electrolytic corrosion and cadmium removal process, which avoids releasing toxic dusts.

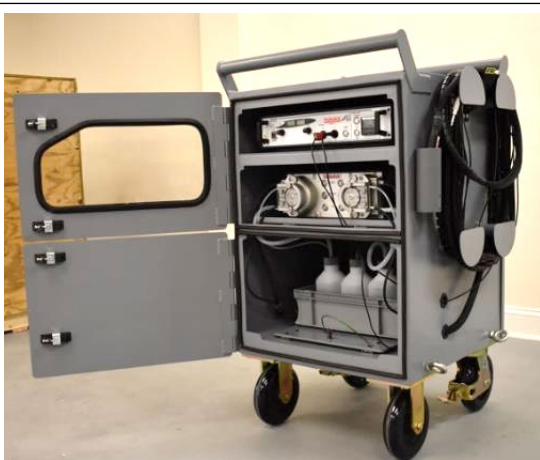
In 2021 the Corrdesa non-drip plating system was qualified as approved ground support equipment for the F-35 (Figure 1), and to date more than 100 of these systems have been shipped worldwide for on-aircraft repair on flight lines and aircraft carriers. They include vibration isolators, non-spill chemical holders, anti-static wheels, brakes, and Cr⁶⁺-free anodize, primer and paint system. Corrdesa also provides worldwide on-site training and certification.

Figure 1. F-35 Mobile Plating Repair System.

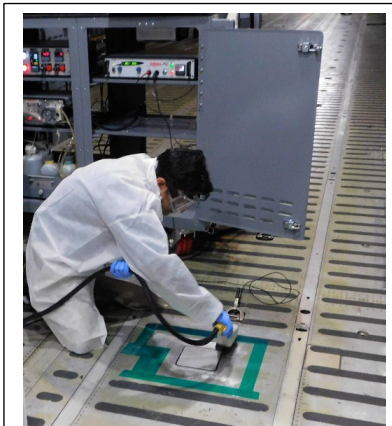
Figure 3. Re-anodizing C-5 cargo floor.

now there had been no way to re-anodize around the patch. Figure 3 shows a technician re-anodizing a C-5 floor using a Corrdesa GSE unit with a large-area anodizing tool. Because the tool leaks neither acid nor fumes, the surrounding area needs no protection, no acid leaks through bolt holes in the floor, and the technician only needs safety glasses, vinyl gloves and lab coat.

The aluminum cargo floor of the C-5 Galaxy, the largest cargo aircraft in the US Air Force, has a similar problem. The floor is often damaged by heavy cargo and patching requires stripping the surrounding anodize. But until

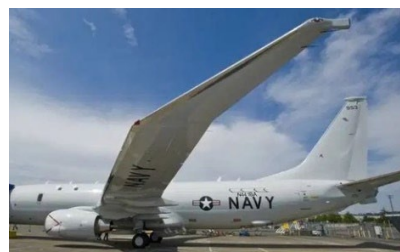
The Navy's new P-8 Poseidon has an extended wing tip with a bare aluminum shield, which corrodes

Figure 4. P-8 Poseidon raked wing tip.

rapidly. Disassembling it for anodizing is a massive job, and the treatment area is 22 sq ft/aircraft. So NAVAIR contracted Corrdesa to create 3 on-wing anodizing systems to overhaul the fleet.
